DMS-DR 2508
NASA-CR 167,650

SPACE SHUTTLE AFRSI DESIGN CRITERIA
DEVELOPMENT TESTS IN THE NASA/AMES
RESEARCH CENTER 11x11-FOOT AND 9x7-FOOT
WIND TUNNELS USING MODEL 123-Ø (OS306A/B)

B. A. Marshall
Rockwell International
Space Transportation & Systems Group

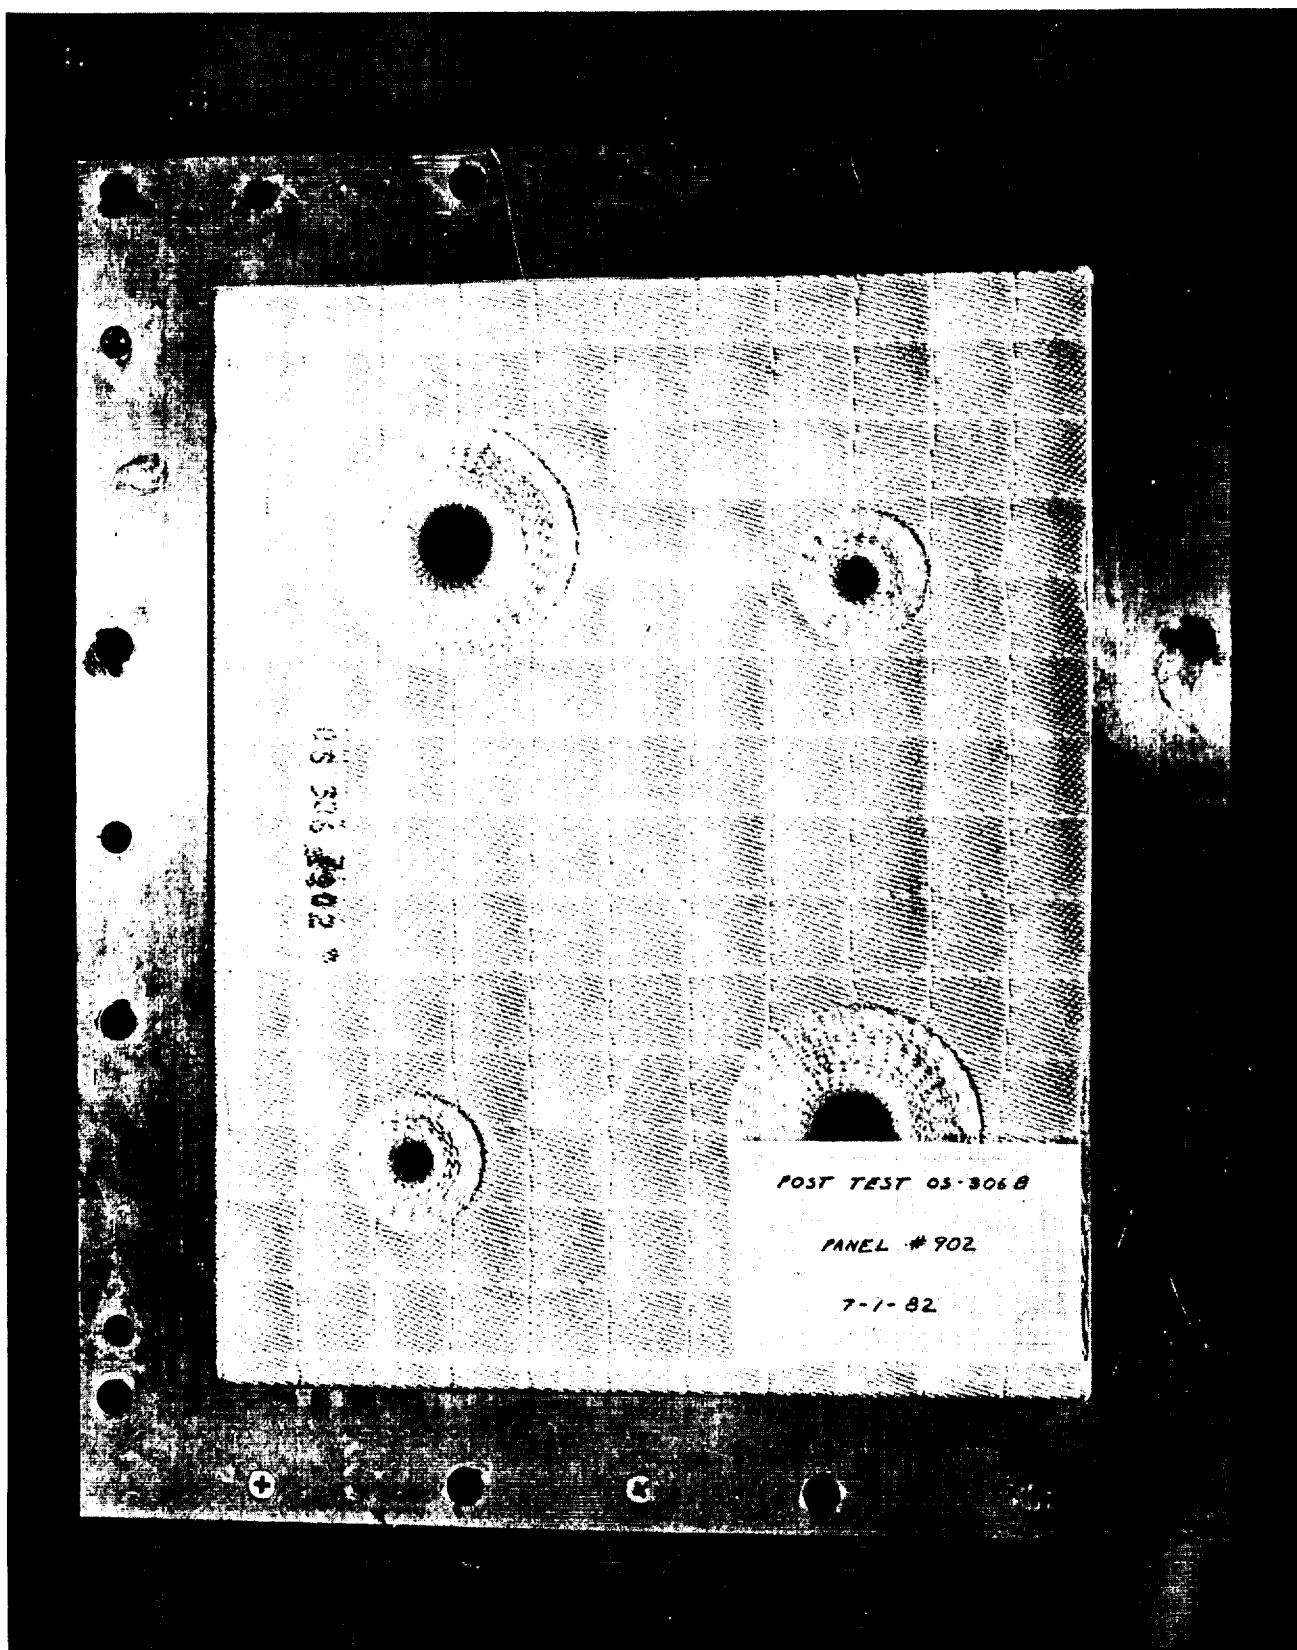
hh. Panel 902H, Unplugged Penetrations

Panel	Q PSF	Time On Condition	*No. of Cycles	Test article Description	Damage to panels as a result of testing
901H	1060	50 Min	6	Plugged Penetrations	Minor fabric frays
902H	1060	50 Min	7	Unplugged penetrations	No damage
903	1060	50 Min	6	Large radius	No damage
904	1060	50 Min	6½	Sharp corner	Fabric frays
905	1245	50 Min	10	Unjointed; shock $\Delta p=2.25$	Broken threads
